Wheel Horse Service Bulletins 1961 - 1990: **#84** Issued: February 1967

Recommended Oil and Filter Change Period - Hydro-Gear Transmissions

Wheel Horse Service Bulletins 1961 - 1990: **#102** Issued: August 1968

**Ignition Switch and Wire Kit #6083 - 1968 10 & 12 H.P. Models with
10 AMP. Alternators**

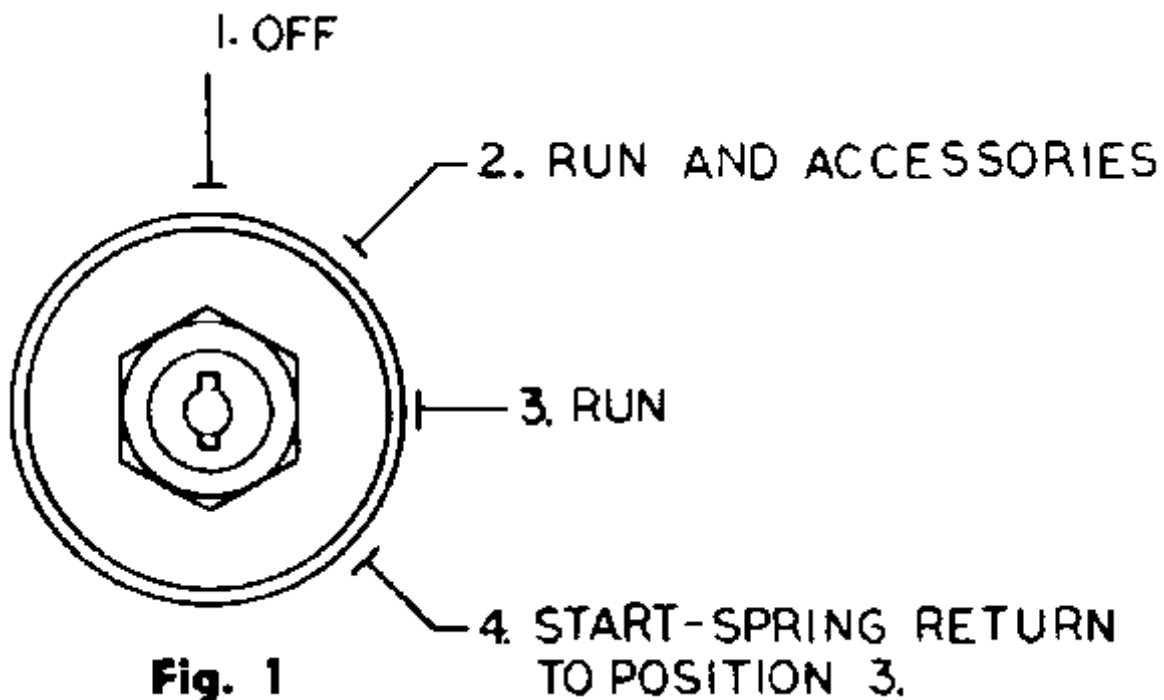
This switch provides 4 positions as shown in Fig 1.

The key must be manually moved from the Run position to the Run and Accessories position before current is supplied to the lights, cigar lighter, or electric clutch, if so equipped. The battery is charged in both the Run and the Run and Accessory position.

In the OFF position the system provides protection from the battery running down due to any accessory being left on and from any possible drain through the rectifier-regulator to ground.

If it is determined that abnormal battery drainage exists through the rectifier-regulator unit we recommend that the ignition switch and wire kit #6083 be installed. NOTE: Make sure that the charging system charges properly as the new type switch will not correct a faulty unit such as a bad battery, regulator or stator. Refer to Wheel Horse Service Bulletin #95 and the related Kohler and Lauson Service Bulletins.

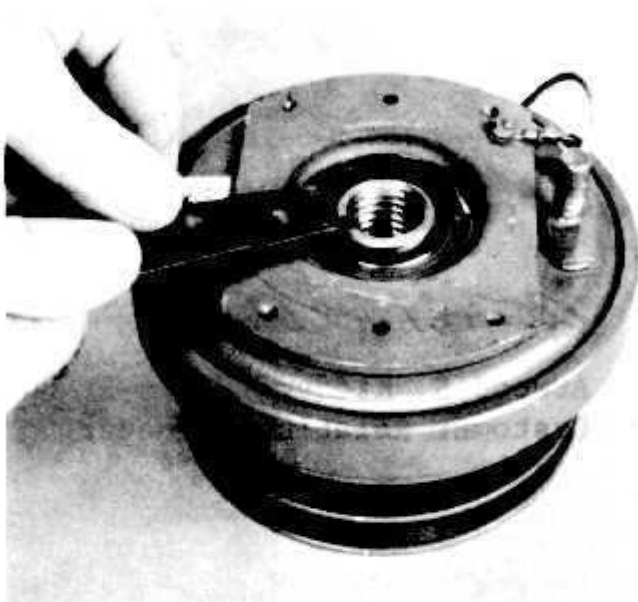
Figure 1

NOTE: These service procedures apply only to replacement of failed field bearings on #7915, #8278 and #9656 Electric Clutches which were original equipment on 1968-70 Electro and GT 14 tractors and a few other early 1971 model long frame tractors.

1. Remove clutch from engine crankshaft using a 1"-8 threaded bolt 5" long as a puller screw.
2. Remove the small external retaining ring as shown in figure 1 (#7915 only).

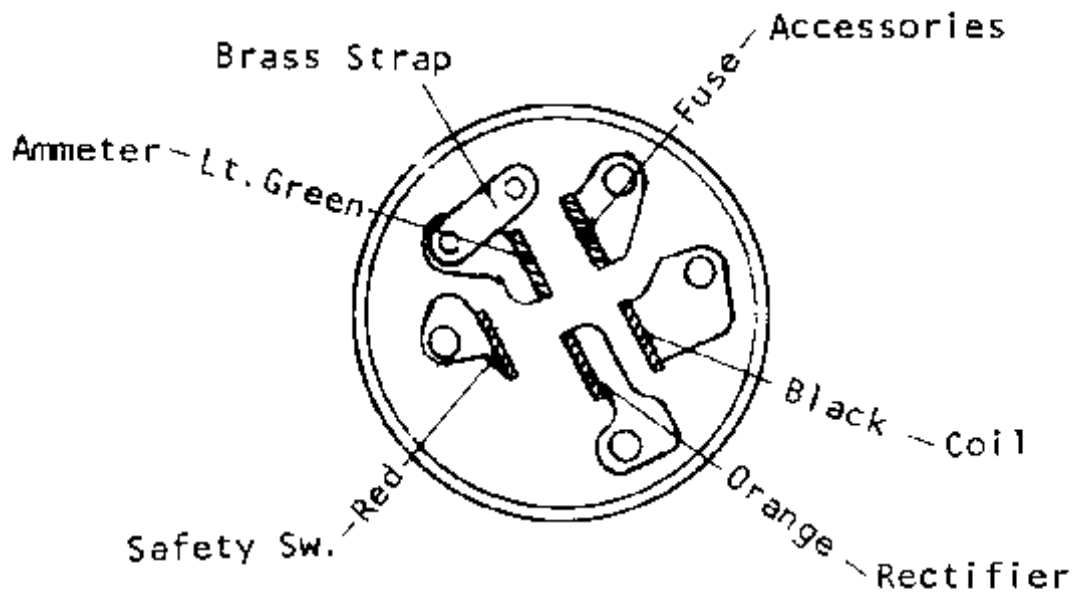
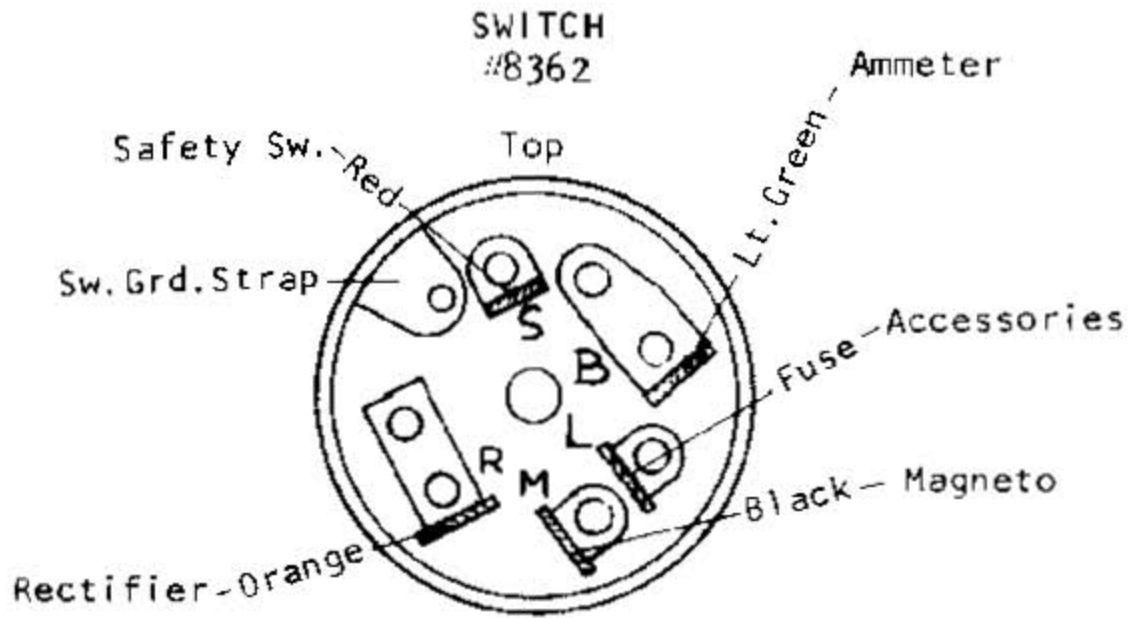
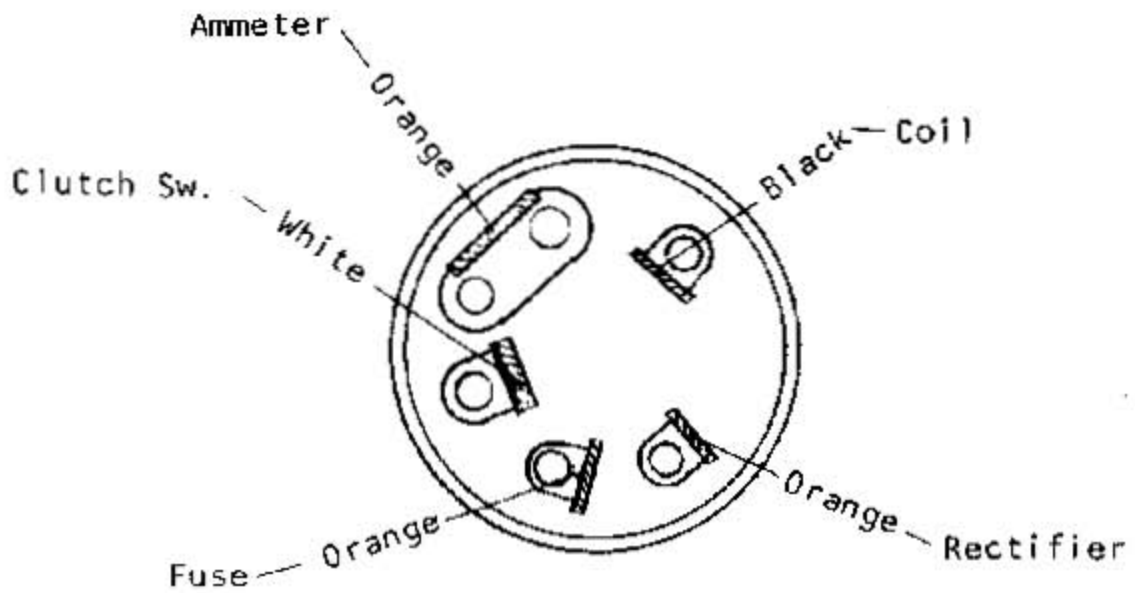
As four (4) different Ignition Switches are used on 1972 models it is extremely important that replacement switches be identified properly to avoid damage to the electrical system.

The four (4) switches are pictured below as seen from the terminal side of the switch. The terminals are identified on the pictures as some of the switch terminals are not marked correctly or are not marked at all.

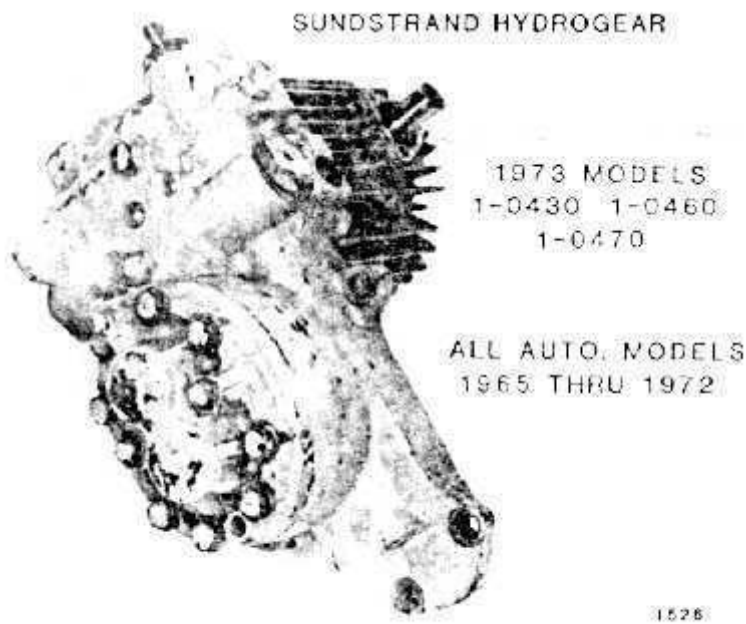
FIG.1

1.1 Toro Wheel Horse has depleted supplies of complete Sundstrand Automatic Transmissions. The following Sundstrand Hydrogear, Sundstrand Piston-Piston Hydrostatic and Conversion Kits for : transmissions are obsolete and no longer available.

2.1 Sundstrand Hydrogear (Fig. 1)-Contact the following company for rebuilding services and repair parts needed.
