Service Bulletin 13

April 28, 1960

SUBJECT: RMR 32-60 ROTARY MOWER

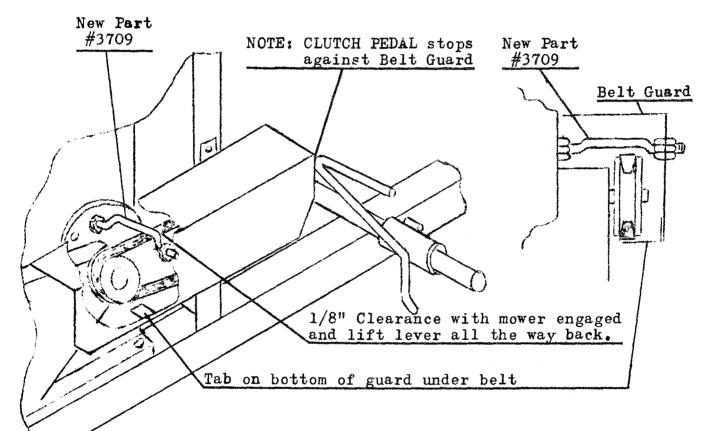
In cases of excessive belt wear of the 30" belt on the rotary mower, a check should be made to be sure that the tube, guard mount, part #3182 is not rubbing on the belt. In the event it is rubbing, a new part #3709 is available at no charge, which will rectify this problem. It should be installed as shown in the cutaway view and be adjusted by turning the bolt so that there is 1/8" clearance with the mower belt engaged (TIGHT) and the lift lever all the way back.

V-Belts are subject to an initial stretch, therefore, belts should be checked for proper tension during the first hour of operation.

Be sure and install belt guard with belt engaged to eliminate the possibility of getting the belt on the outside of the tab on the bottom of the guard.
